Home Report

Property address: Shamrock Lea
Eday
Orkney
KW17 2AB

Report prepared by: Orkney Surveying Services
Castlehowe
Sower Road
Orphir
Orkney
KW17 2RE

Date of inspection: 8th May 2017

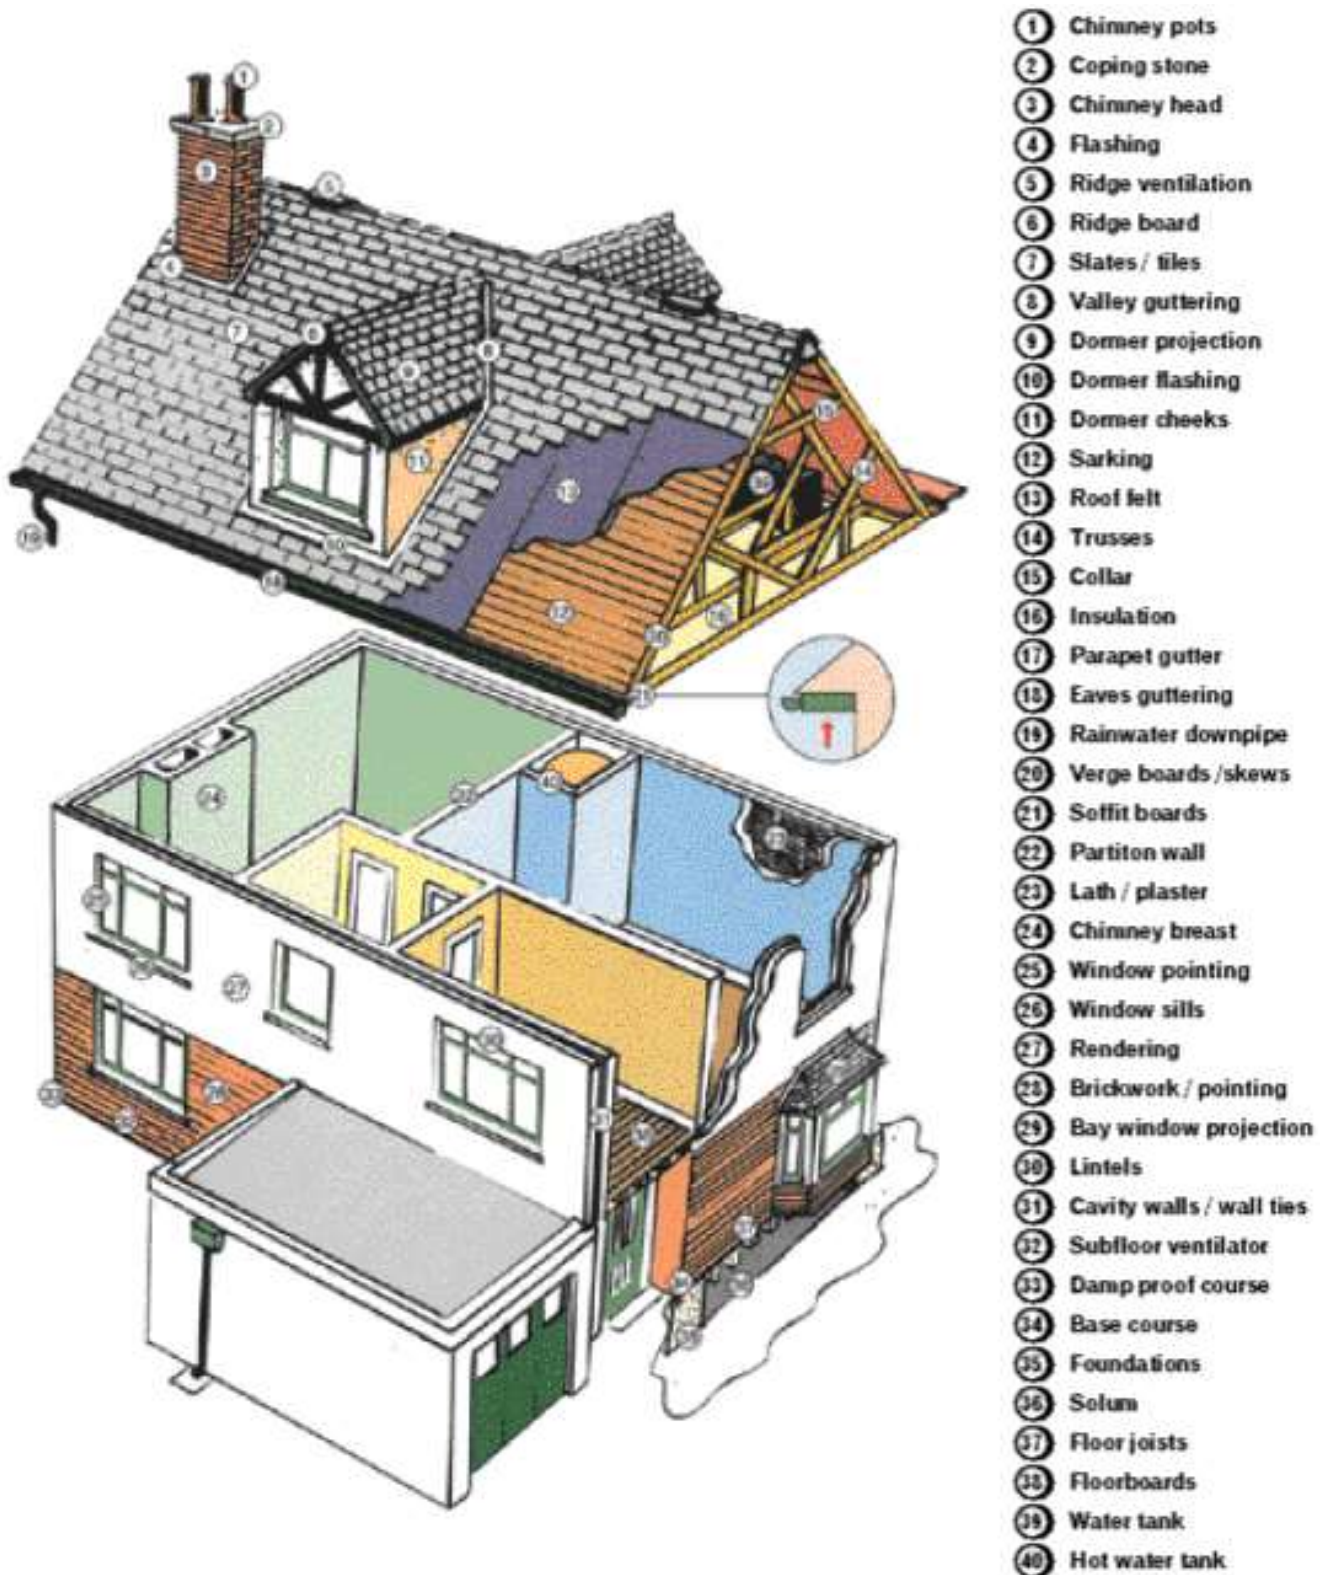
Sectional diagram showing elements of a typical house

Reference may be made in this report to some or all of the above component parts of the property. This diagram may assist you in locating and understanding these terms.
