Home Report

Property address: Hillpark
Lady Village
Sanday
Orkney
KW17 2BW

Date of inspection: 6th October 2017
Updated 11th January 2018

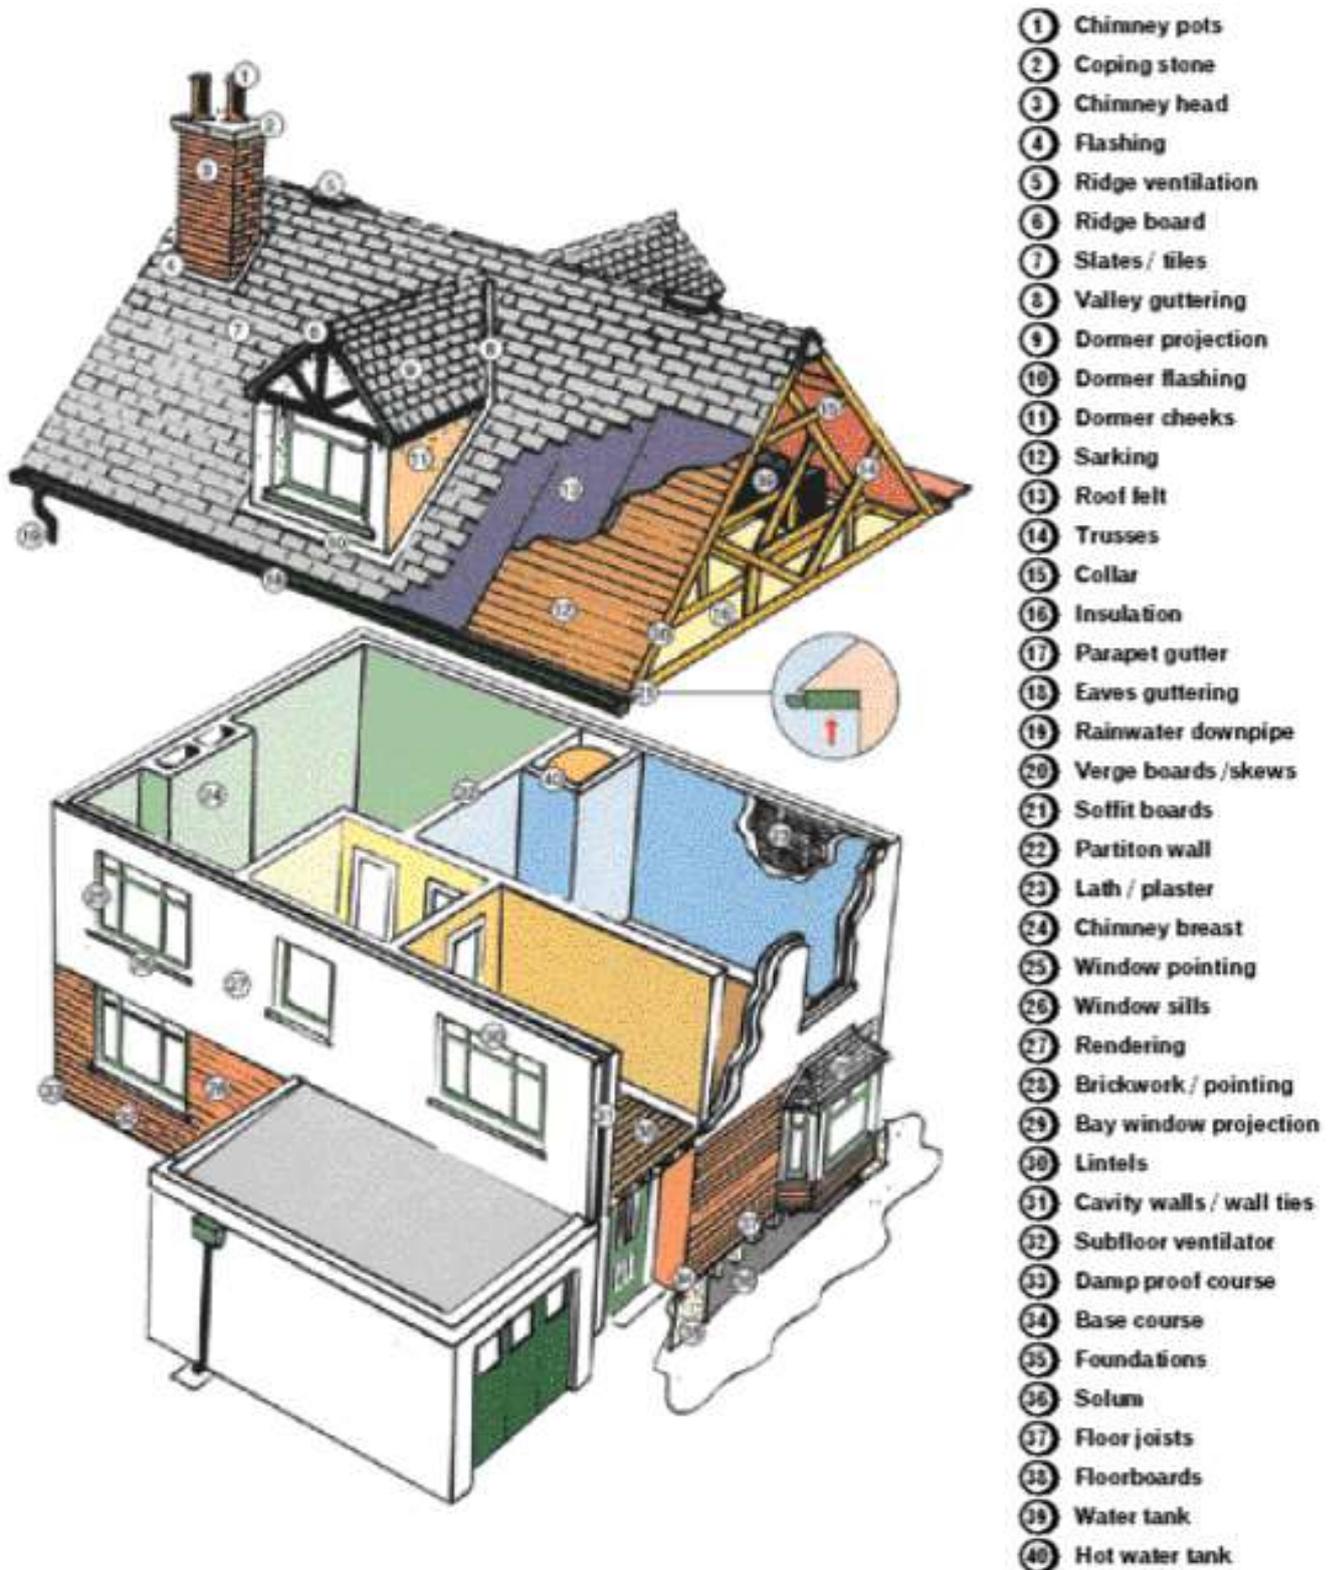
Sectional diagram showing elements of a typical house

Reference may be made in this report to some or all of the above component parts of the property. This diagram may assist you in locating and understanding these terms.
