Home Report

Property address: Scapa Sands
Longhope
Orkney
KW16 3PA

Date of inspection: 30th November 2017

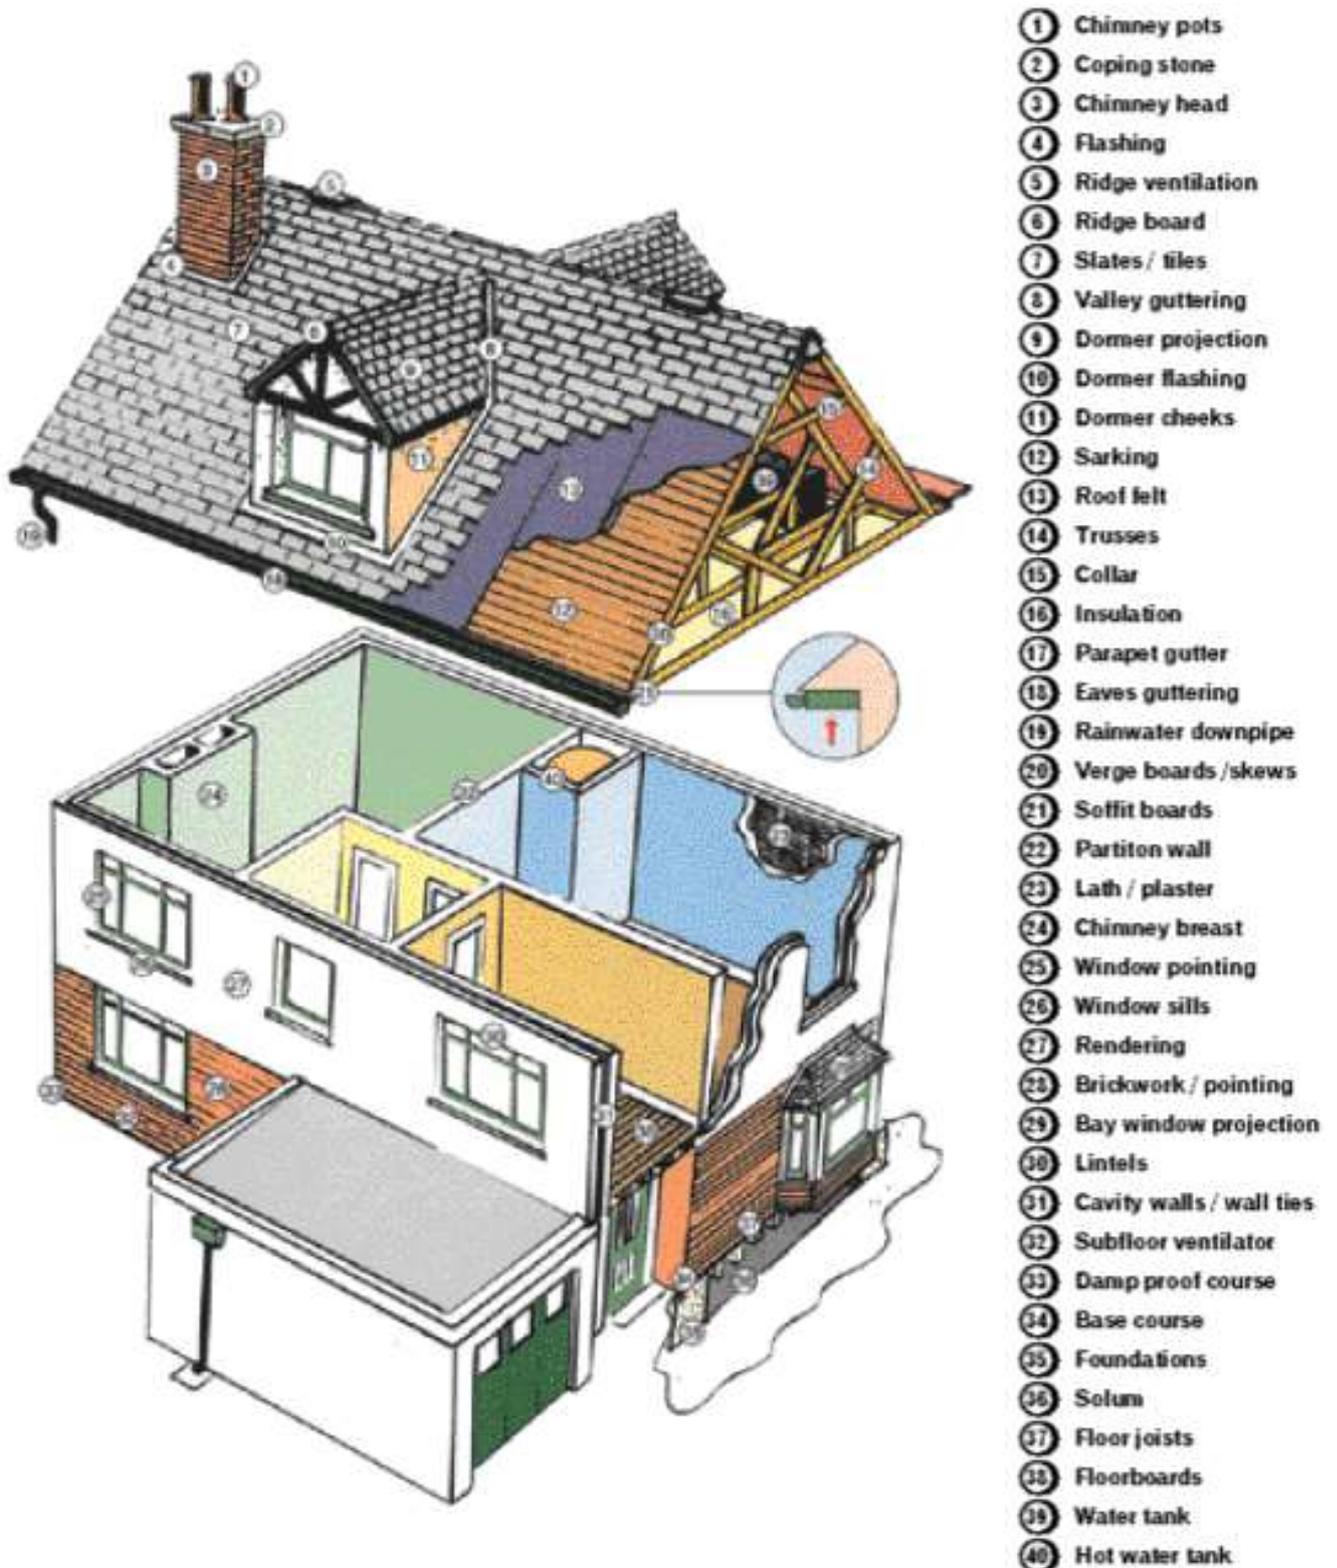
Sectional diagram showing elements of a typical house

Reference may be made in this report to some or all of the above component parts of the property. This diagram may assist you in locating and understanding these terms.
