Home Report

Property address: Roadside Cottage
Lady Village
Sanday
Orkney
KW17 2BW

SINGLE SURVEY

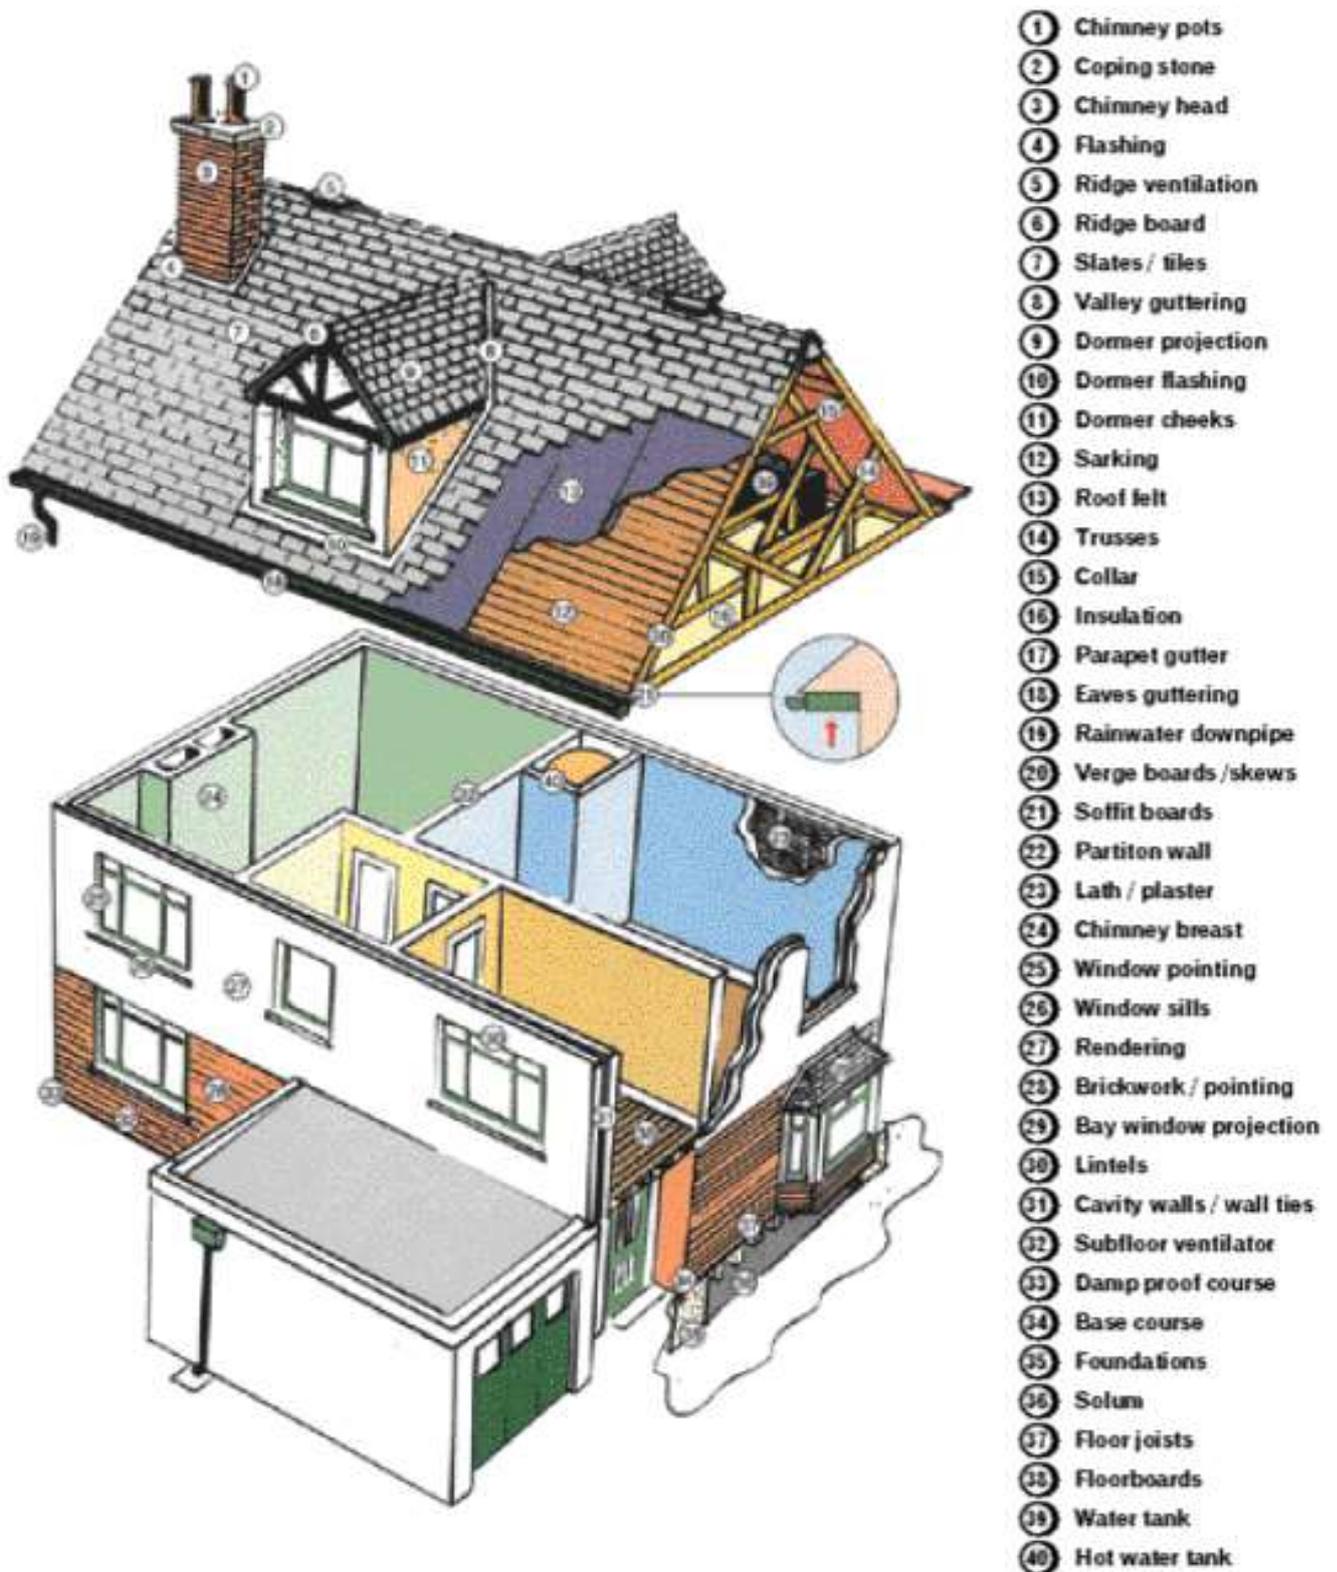
Sectional diagram showing elements of a typical house

Reference may be made in this report to some or all of the above component parts of the property. This diagram may assist you in locating and understanding these terms.
