Home Report

Property address: Honeysuckle Cottage
Longhope
Hoy
Orkney
KW16 3PQ

Date of inspection: 28th June 2018

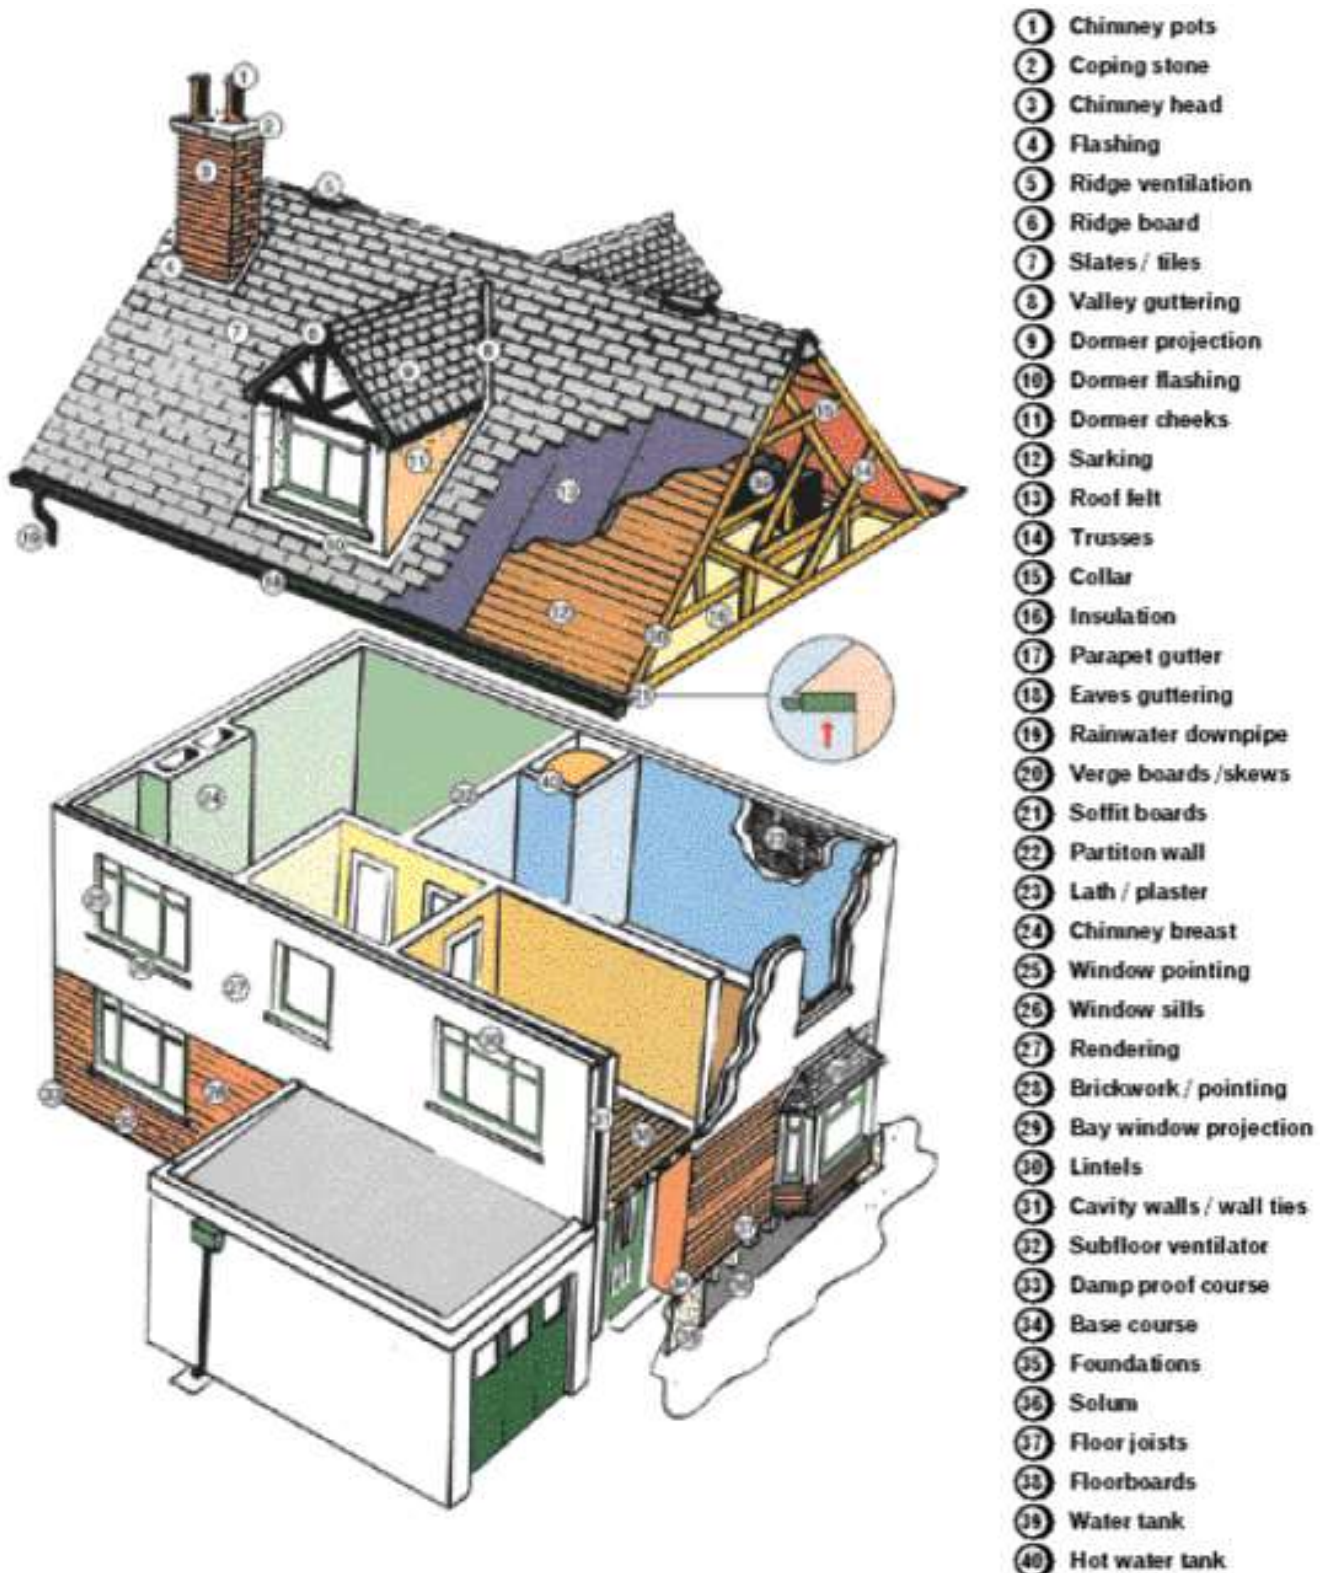
Sectional diagram showing elements of a typical house

Reference may be made in this report to some or all of the above component parts of the property. This diagram may assist you in locating and understanding these terms.
