# Home Report

**Property address:** Twargarn  
Harray  
Orkney  
KW17 2LF

**Date of inspection:** 12<sup>th</sup> October 2018

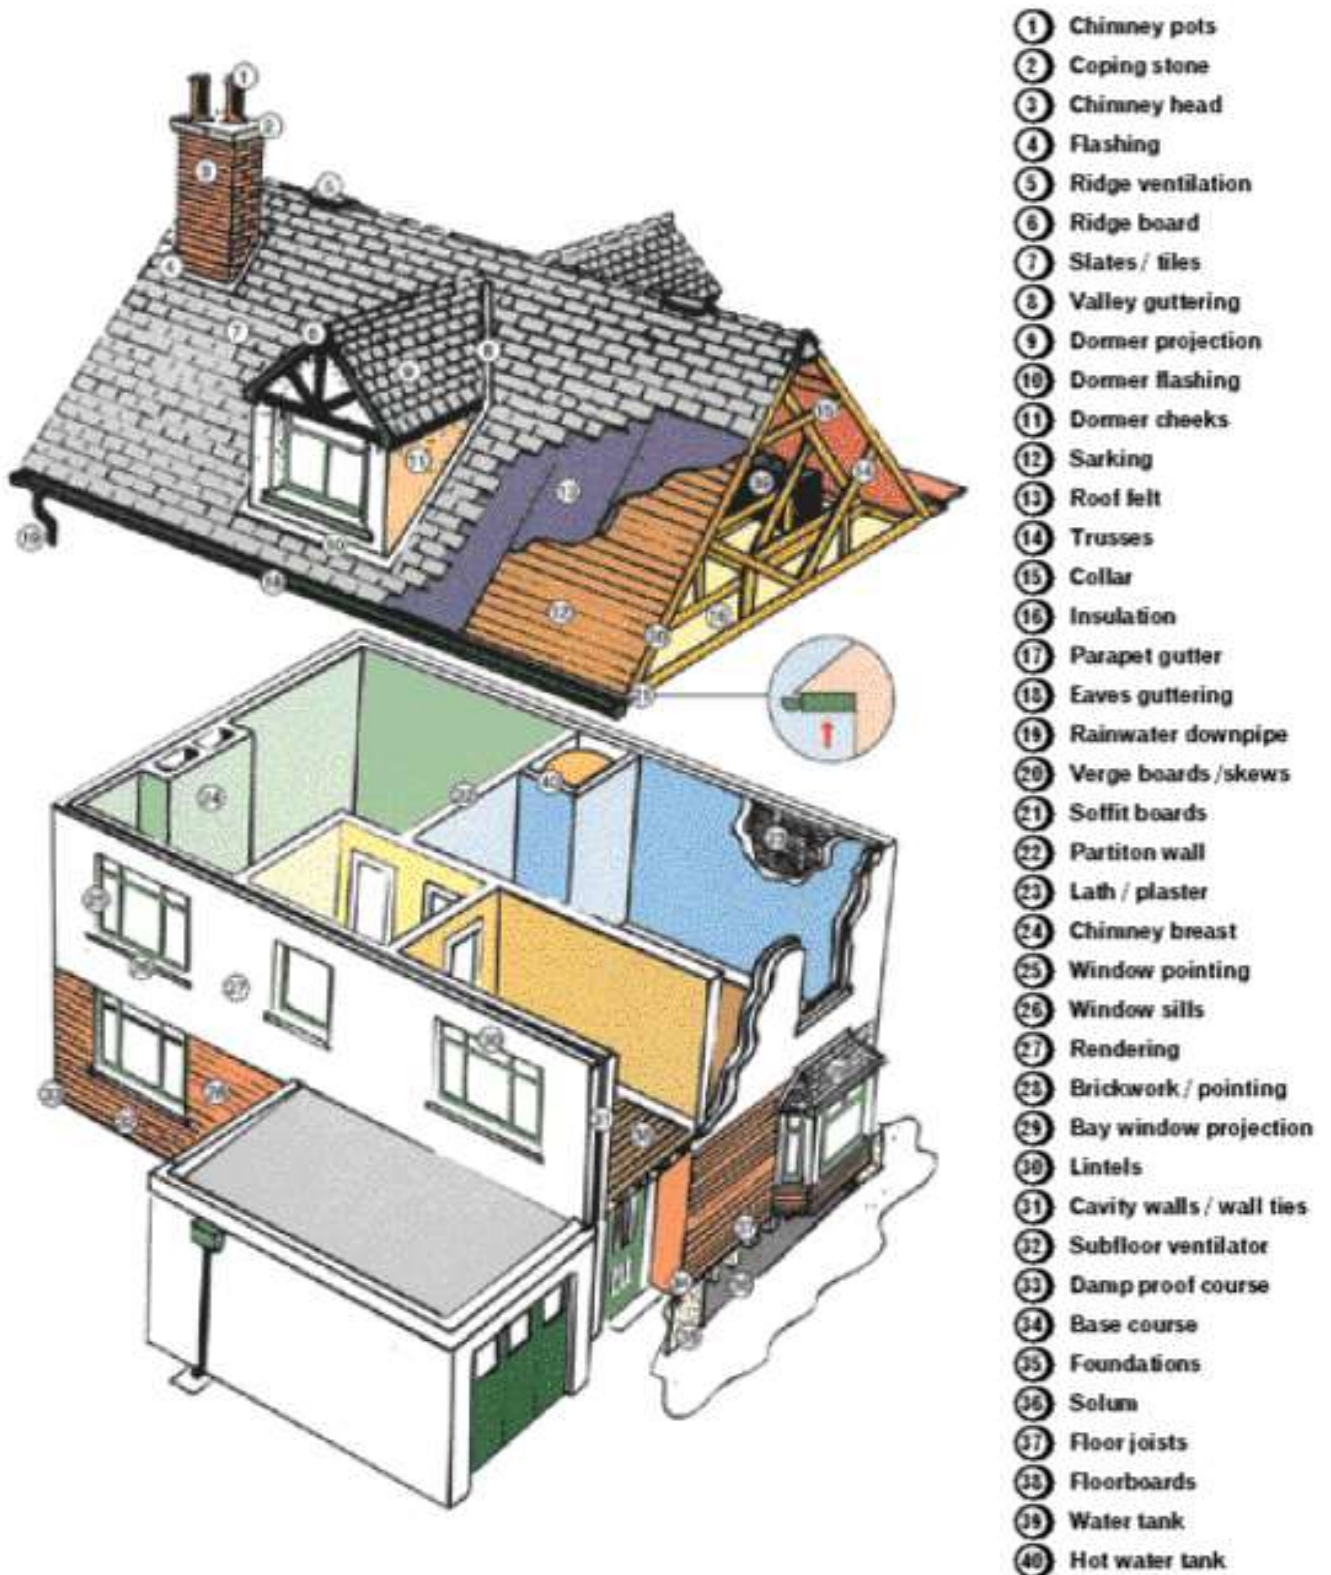
## Sectional diagram showing elements of a typical house

Reference may be made in this report to some or all of the above component parts of the property. This diagram may assist you in locating and understanding these terms.
