Survey Report On

**Kringlafiold,
Cairston Drive,
Stromness,
Orkney,
KW16 3JL.**

Date of inspection: 4th December 2018.

Prepared by: Christopher Park, M.R.I.C.S.,
Chartered Surveyor,
R.I.C.S. Registered Valuer.

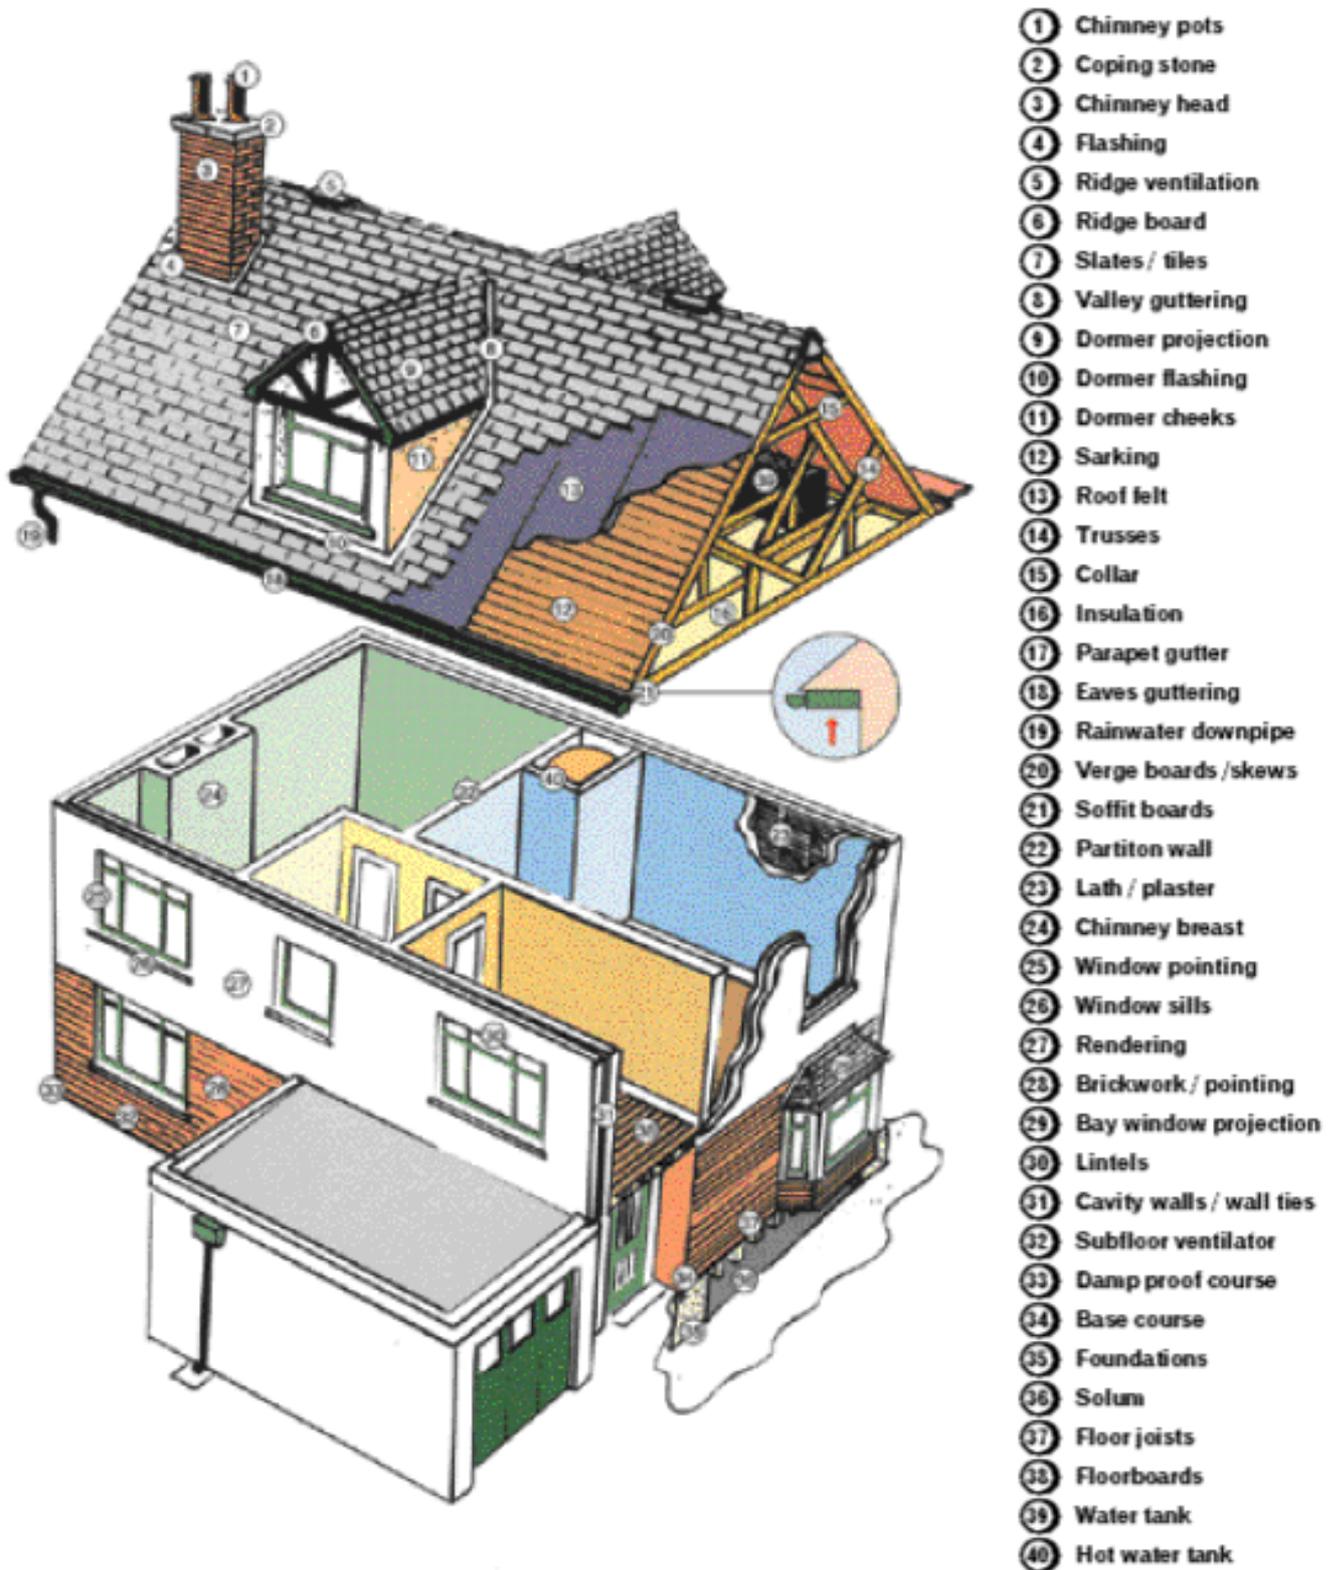
Sectional diagram showing elements of a typical house

Reference may be made in this report to some or all of the above component parts of the property. This diagram may assist you in locating and understanding these terms.
