# Home Report

**Property address:** 2 King Harald Kloss  
Kirkwall  
Orkney  
KW15 1FT

**Date of inspection:** 8<sup>th</sup> April 2019

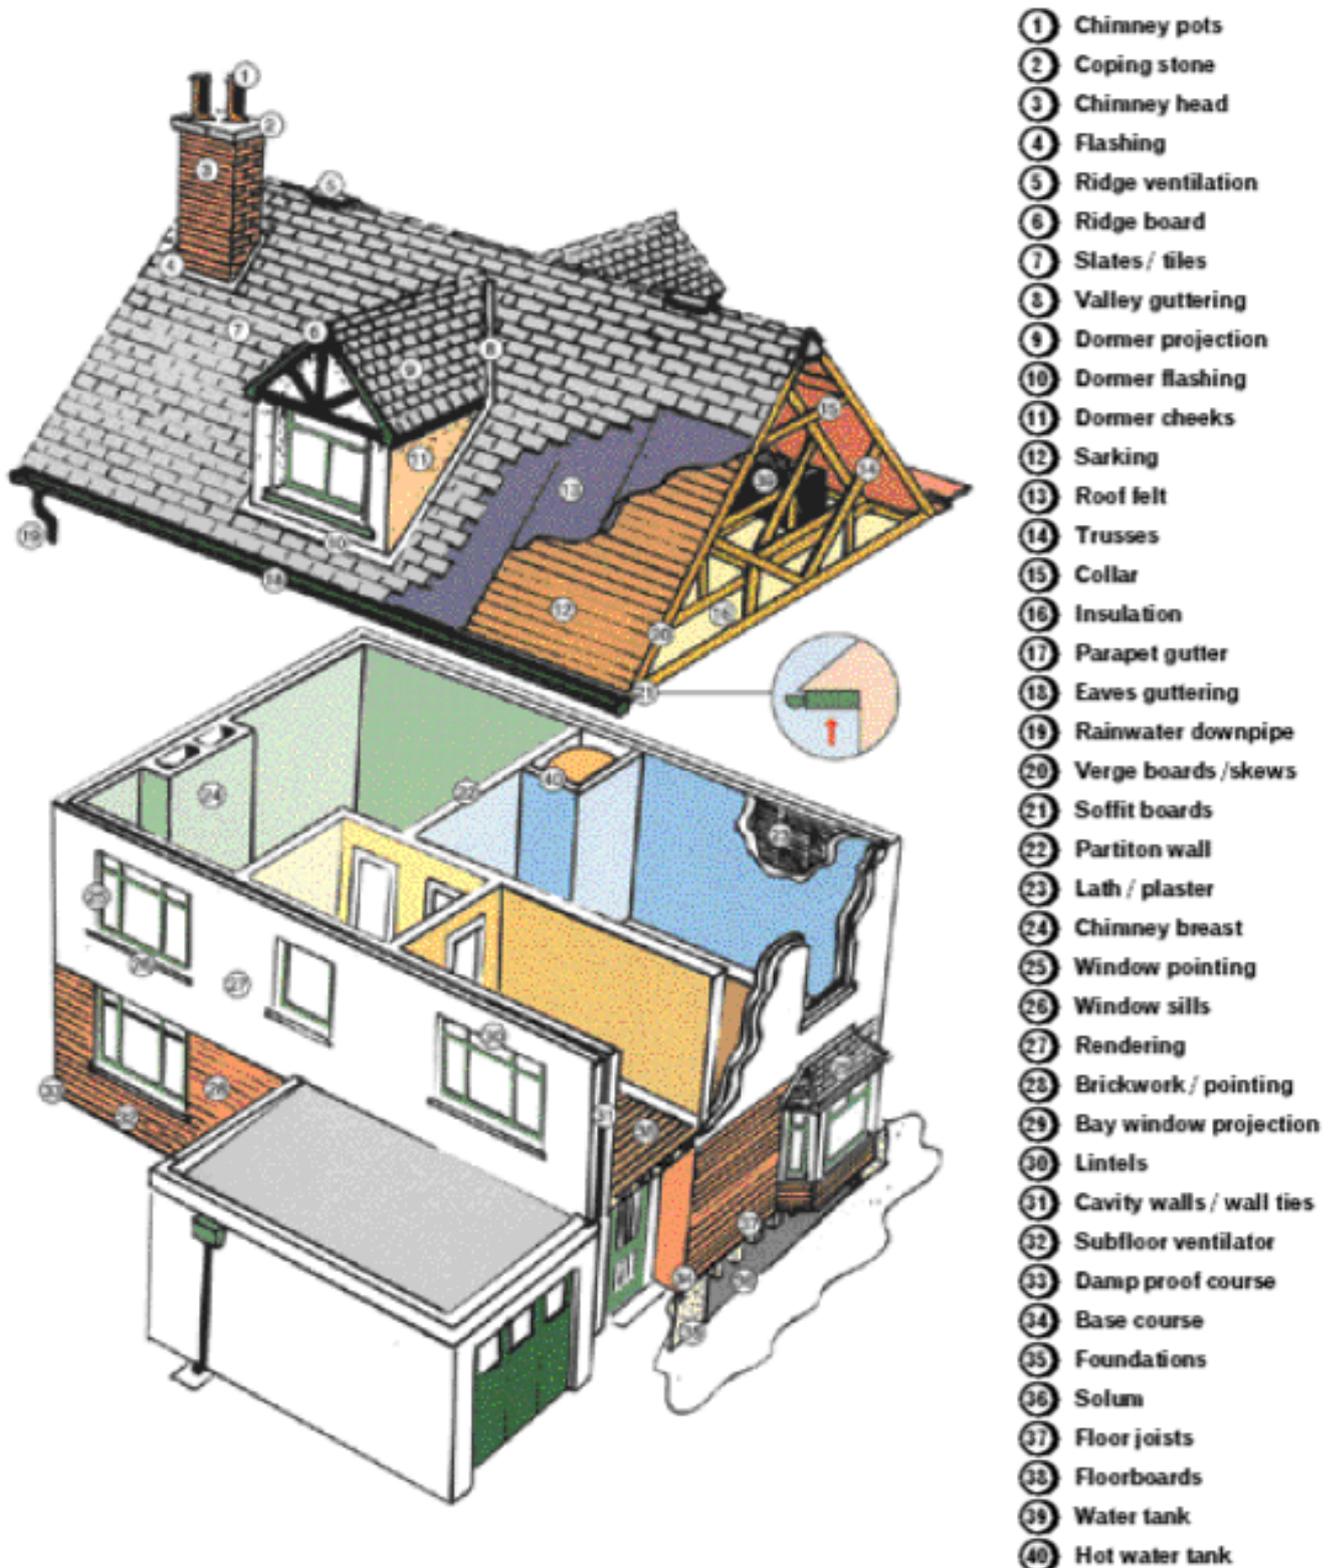
## Sectional diagram showing elements of a typical house

Reference may be made in this report to some or all of the above component parts of the property. This diagram may assist you in locating and understanding these terms.
