# Home Report

**Property address:** Cartair  
Grainepark  
Kirkwall  
Orkney  
KW15 1UL

**Date of inspection:** 19<sup>th</sup> September 2020

Cartair comprises a semi-detached bungalow, with integral garage and garden ground.

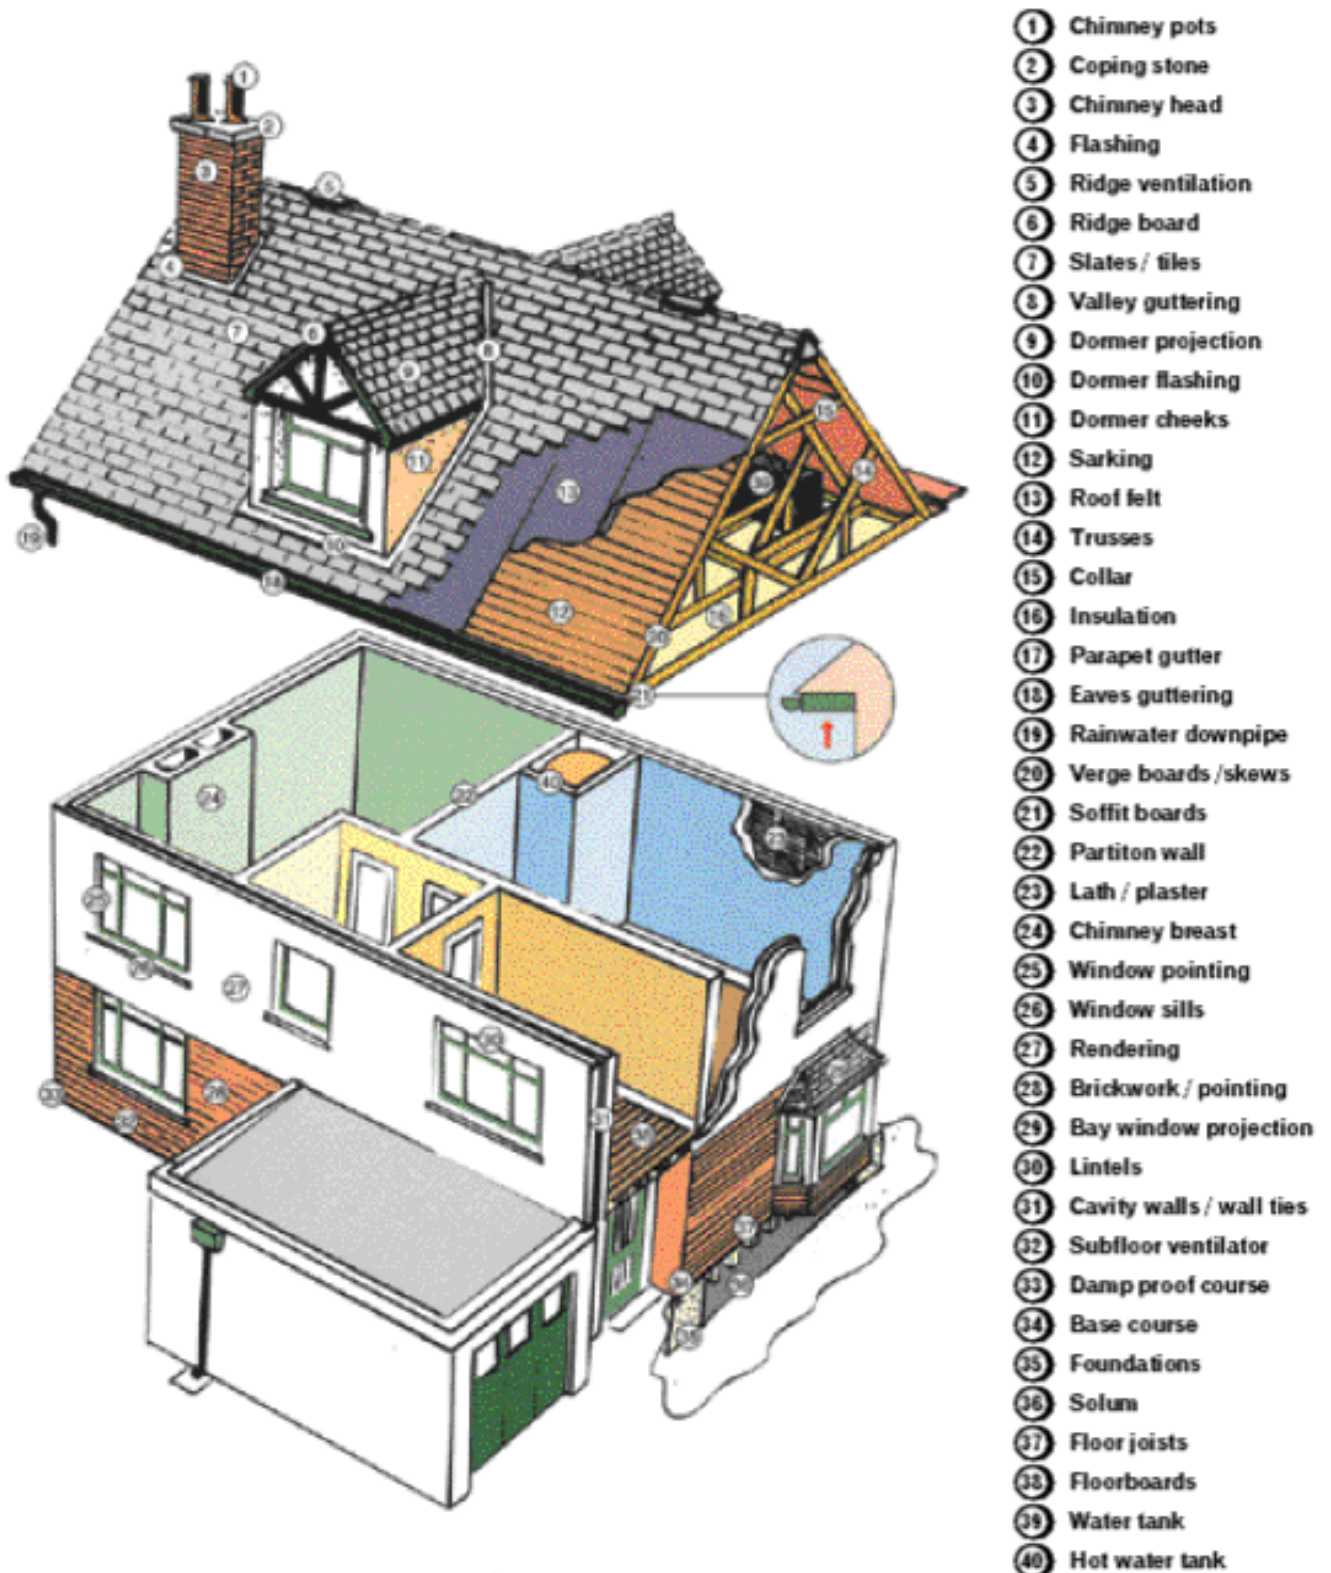
## Sectional diagram showing elements of a typical house

Reference may be made in this report to some or all of the above component parts of the property. This diagram may assist you in locating and understanding these terms.
