Survey Report on: Netherlee,
Deerness,
KW17 2QH.

Date of inspection: 29th October 2020.

Prepared by: Stephen J Omand, F.R.I.C.S.,
Chartered Valuation Surveyor,
R.I.C.S. Registered Valuer.

1. INFORMATION AND SCOPE OF INSPECTION

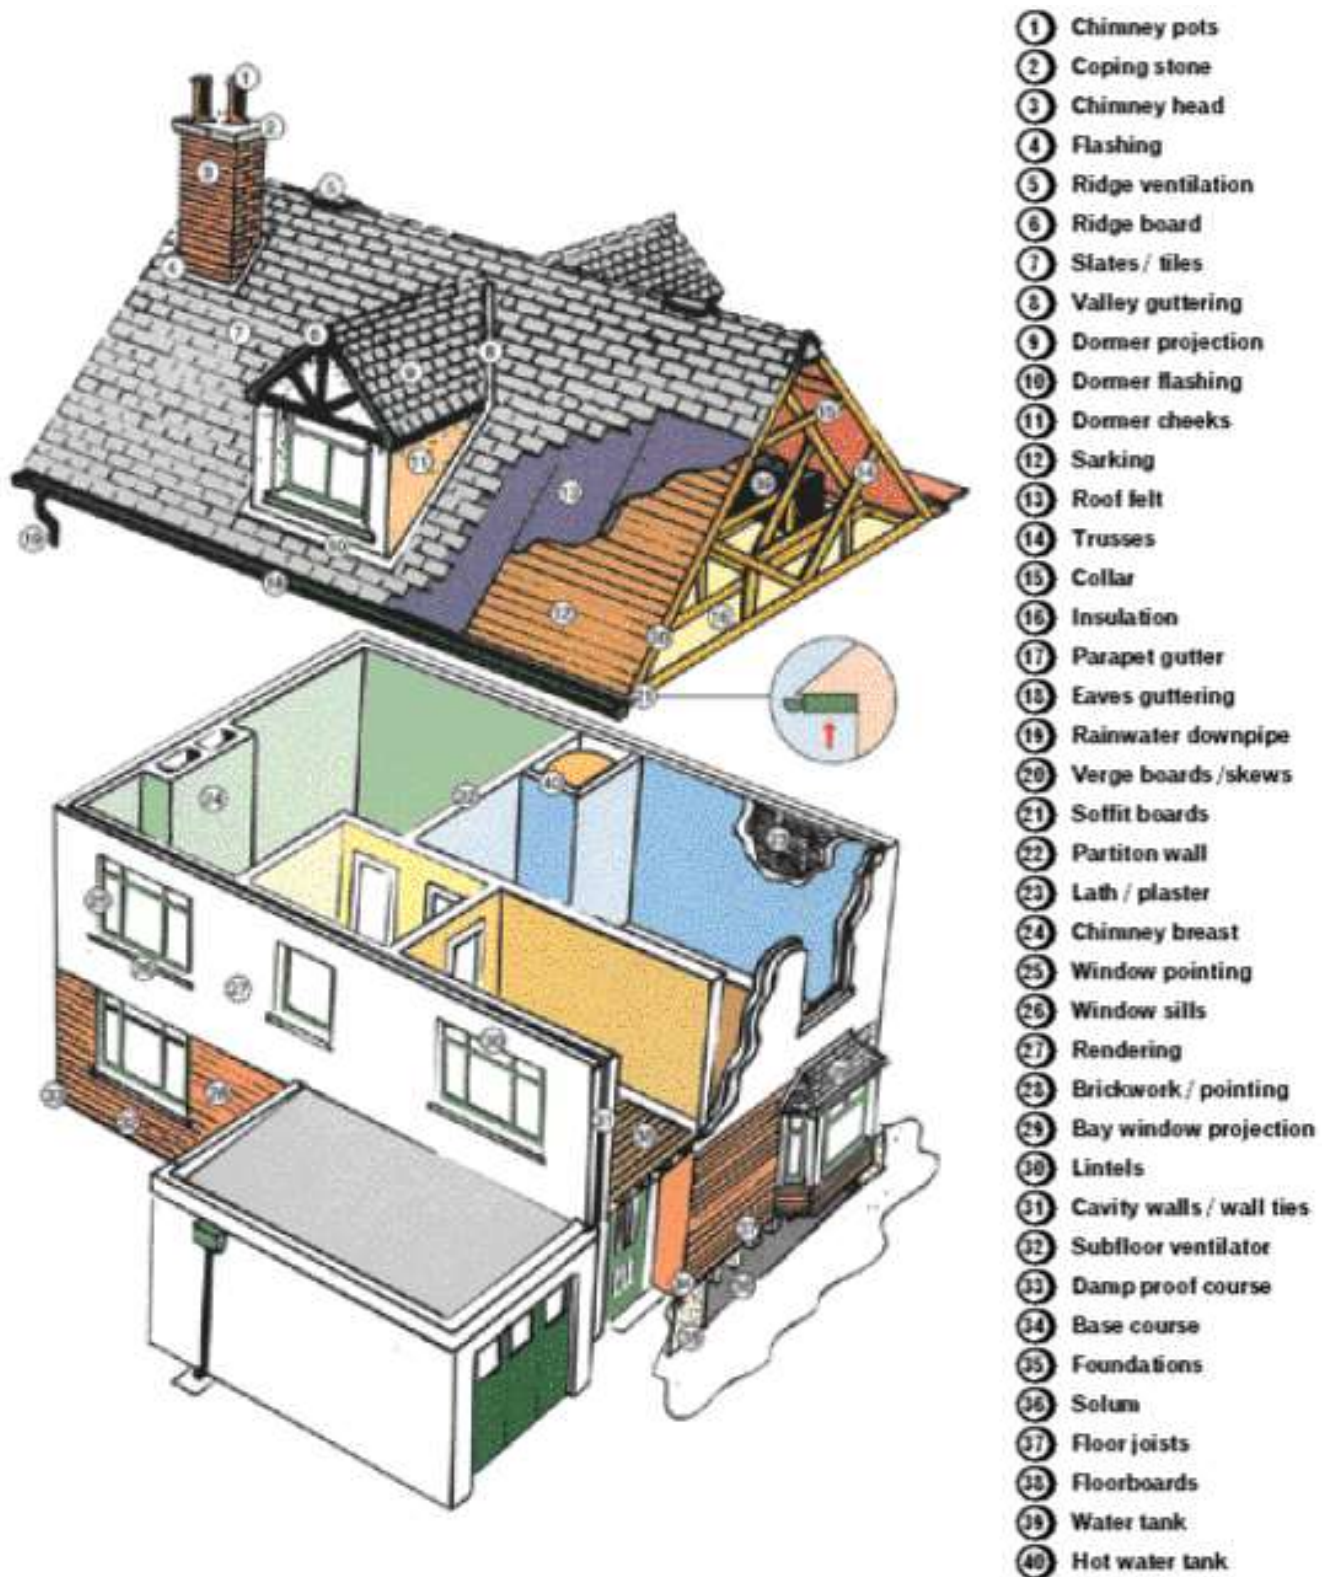
Sectional diagram showing elements of a typical house

Reference may be made in this report to some or all of the above component parts of the property. This diagram may assist you in locating and understanding these terms.
